# MID Resumen de Actividades: 2024

Alberto Chavez  
MID – Inspector

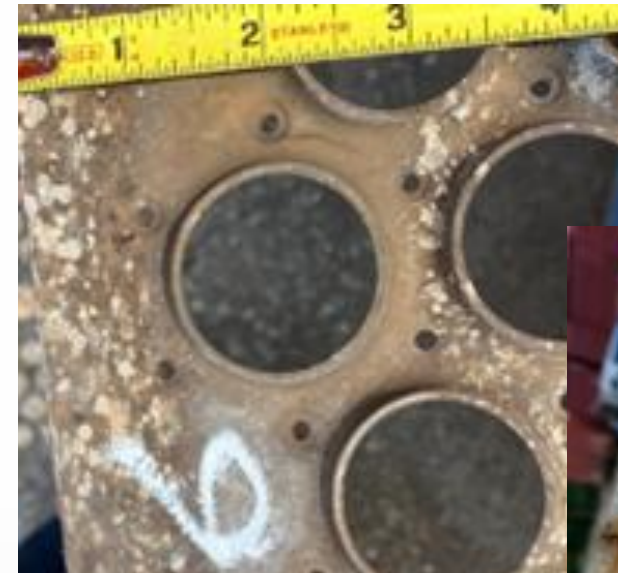
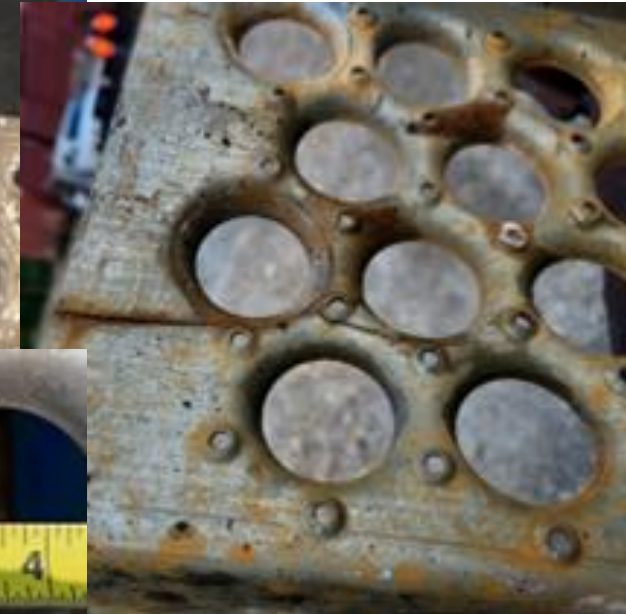
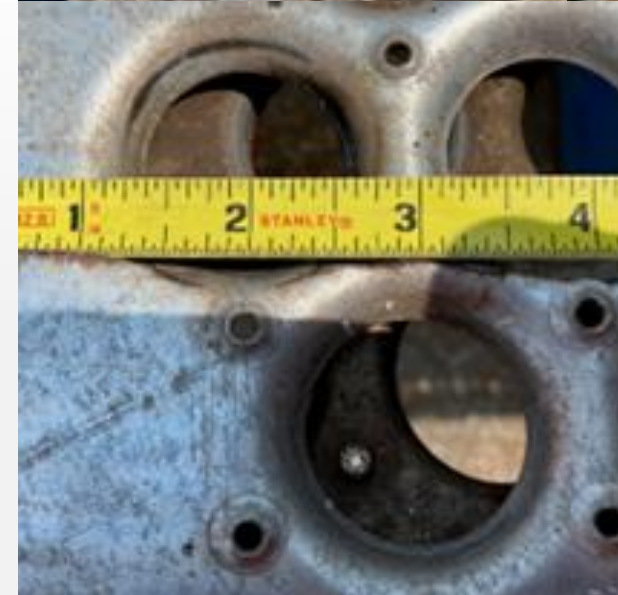
- Ejemplos de componentes reemplazados que no eran accionables

1. At Any Time
  - a. Missing
  - b. Broken
  - c. Loose
  - d. Bent such that the walking surface varies in height by more than 1 inch in any 2 feet when not in use (other than by design).
  - e. Improperly applied (for example brake step or end platform upside down)
  - f. Obstructed (other than by design).
2. When Car is on Shop or Repair Track for Any Reason
  - a. Torch-cut hand brake chain cutout in plate type board.
  - b. Corrosion that reduces metal thickness by 20% or more.
  - c. Board crack with total length spanning:
    - (1) 12 inches or more in any direction. See Figure 53.1
    - (2) Across half or more of the board width (transverse). See Figure 53.2
  - d. Plate type board crack with total length of 6 inches or more and located within 6 inches of where handhold attaches to board. See Figure 53.3.

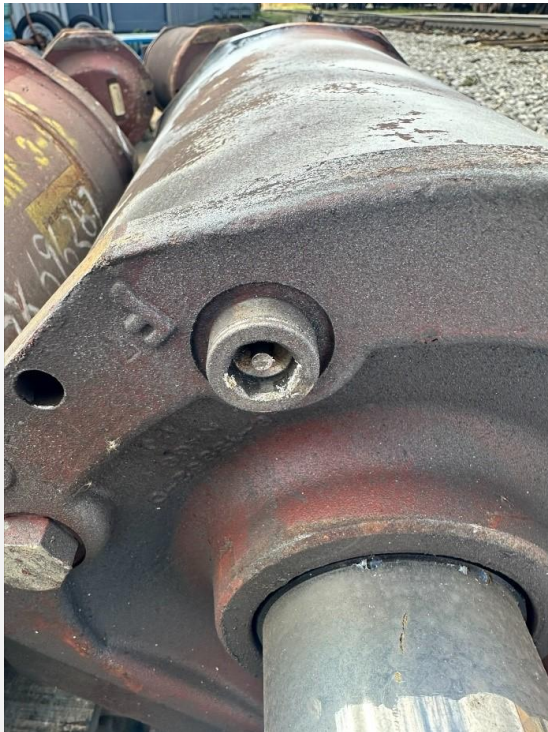
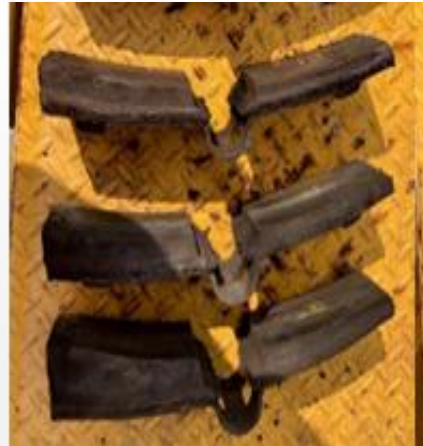
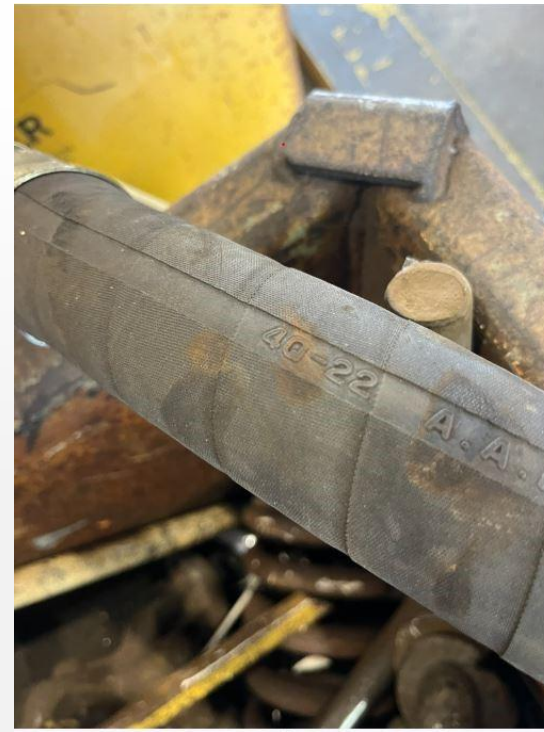
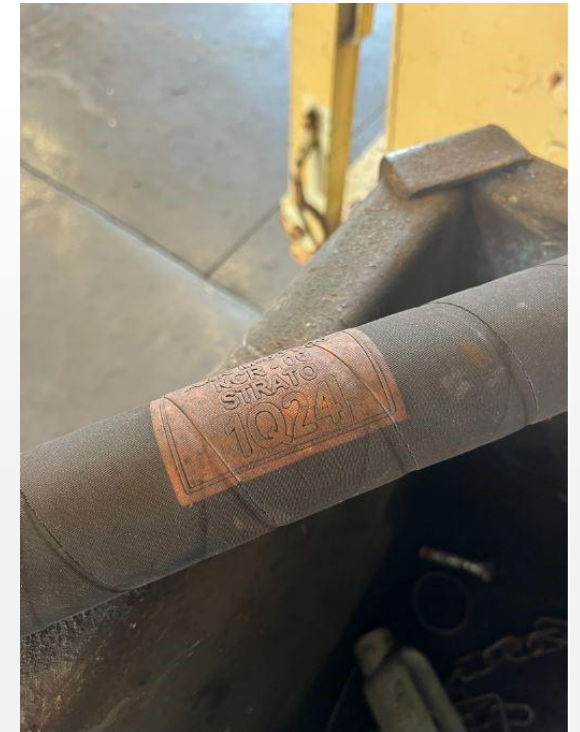
- Ejemplos de componentes reemplazados que no eran accionables

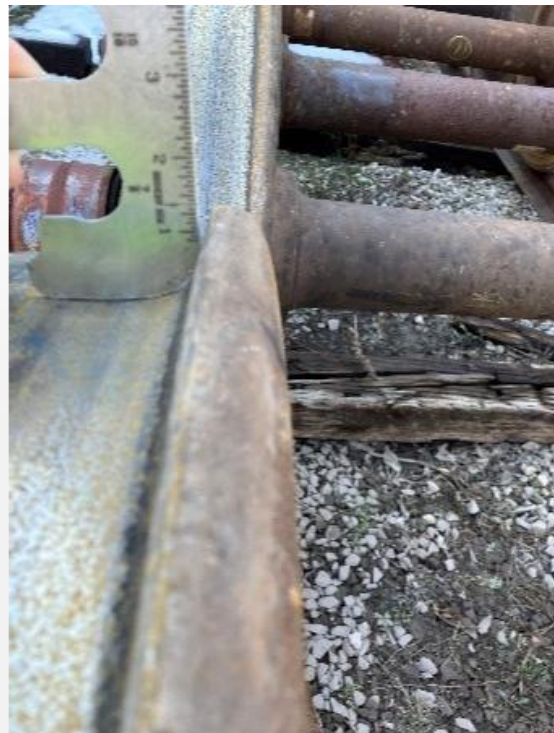
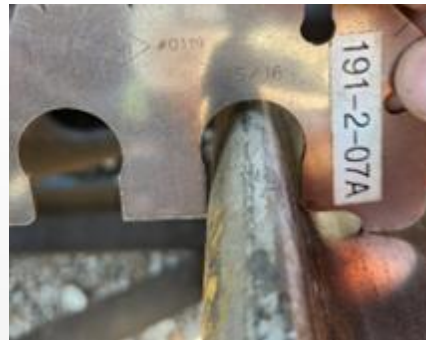
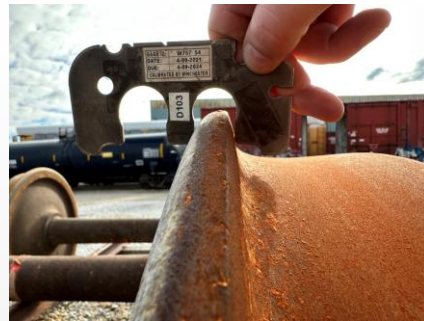
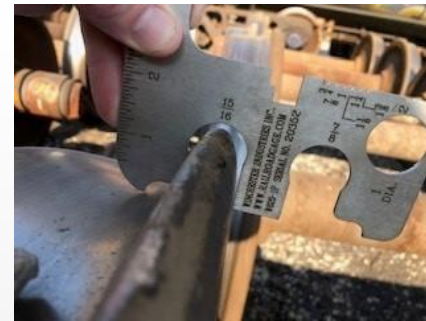
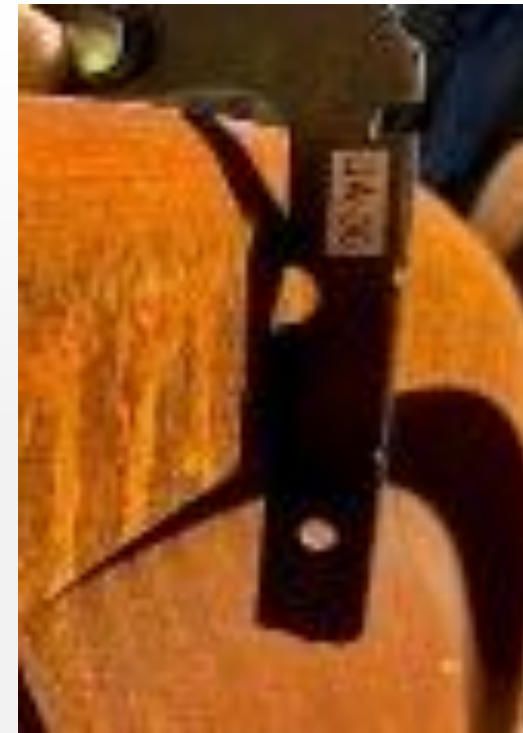
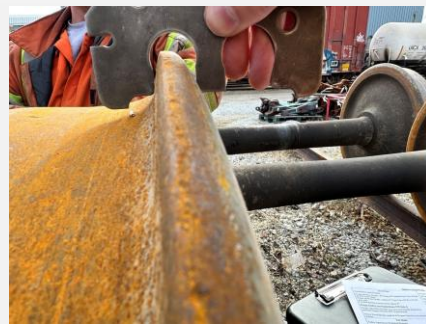
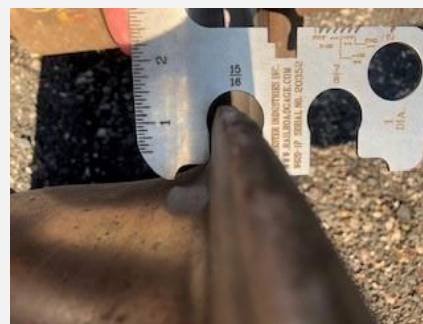
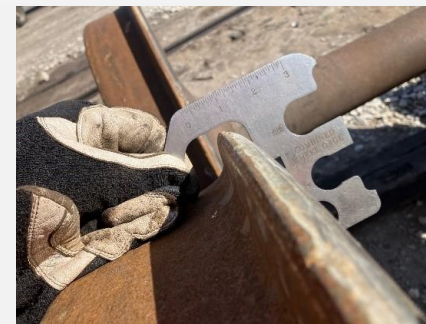
- Ejemplos de componentes reemplazados que no eran accionables

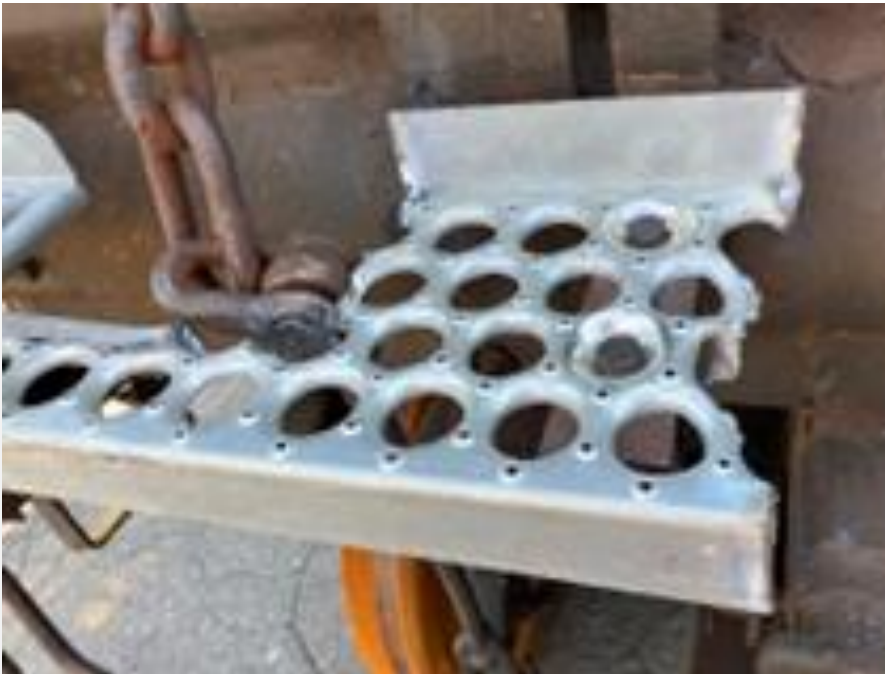
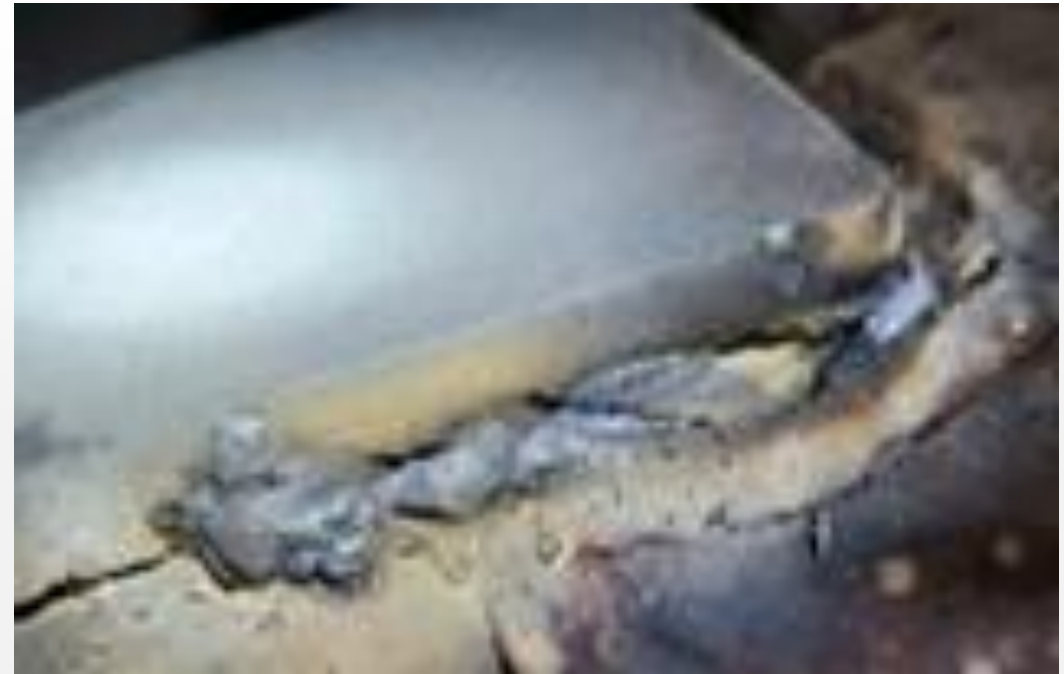
- Ejemplos de reparaciones impropias

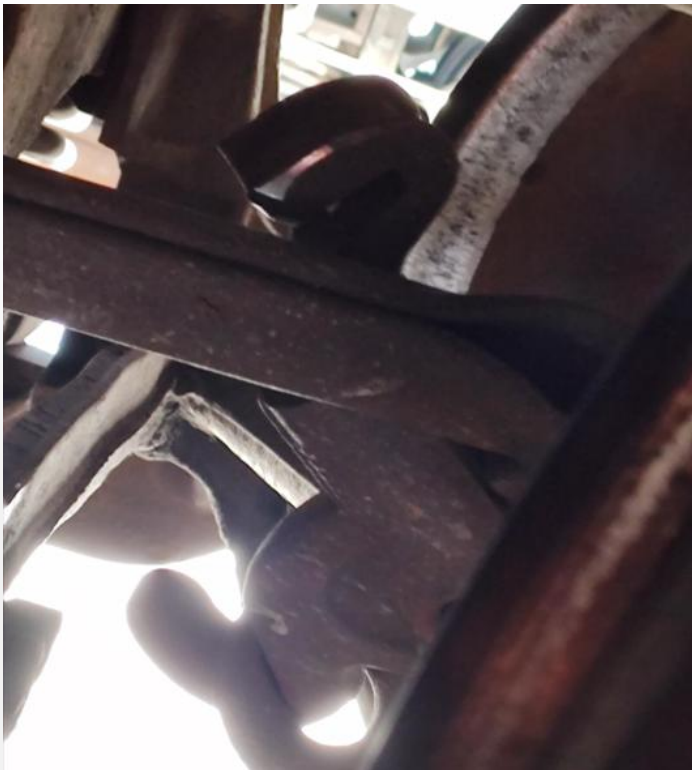
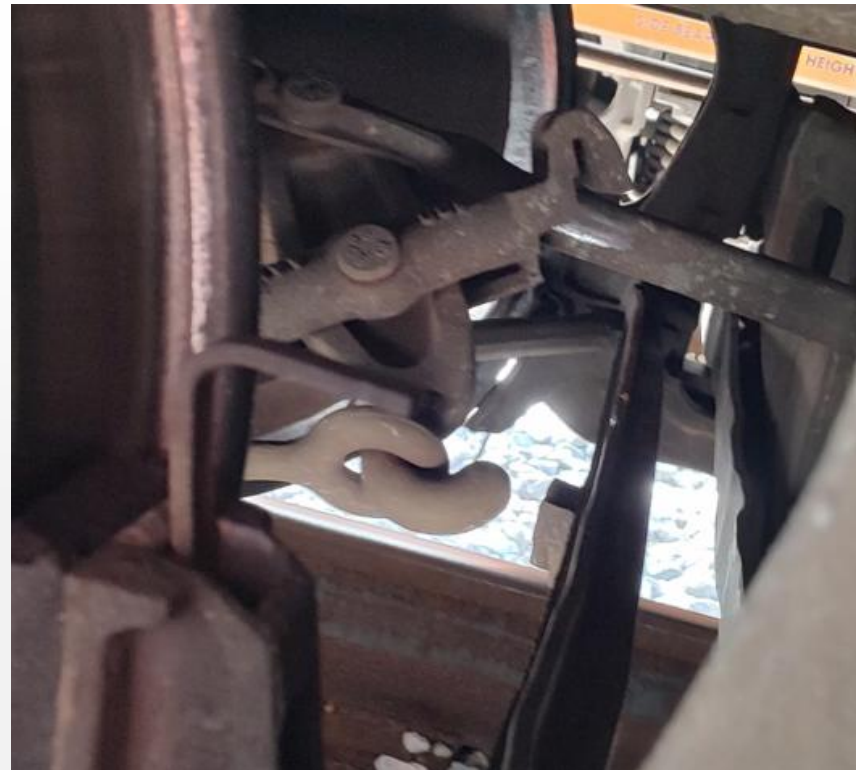
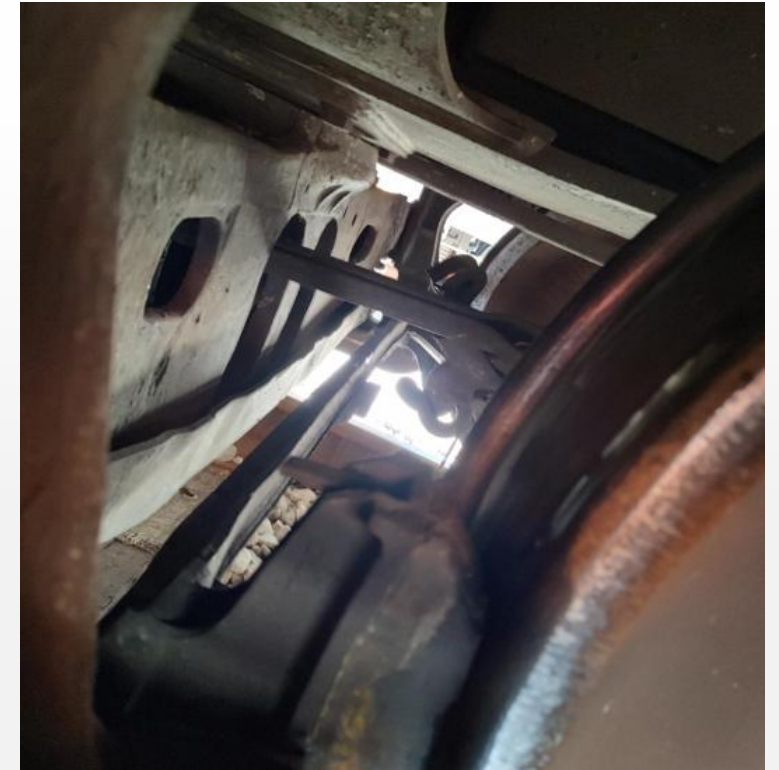
- Examples of actionable components not repaired (Outbound)
