“Camera system defect detection / Detección de defectos mediante sistema de cámaras”

Jorge Luevano KCSM

25 / 26 de Octubre de 2022

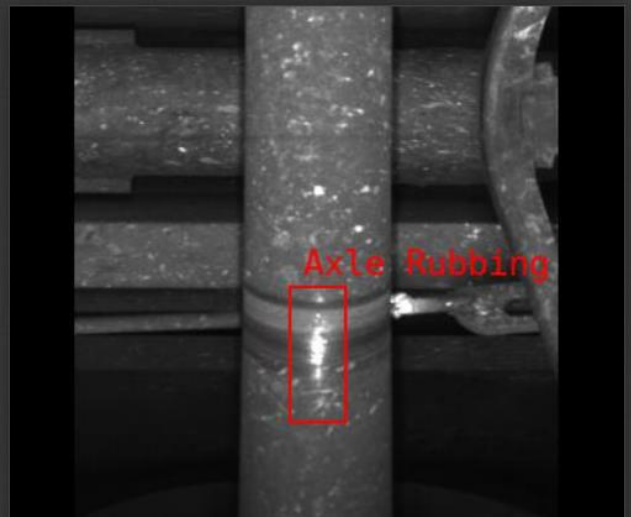
Algorithm Axle Rubbing
(D0004)

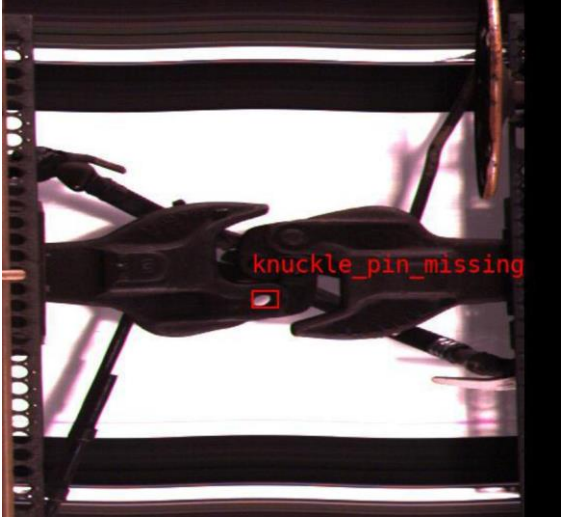
Algorithm Knuckle Pin Missing
(D0029)

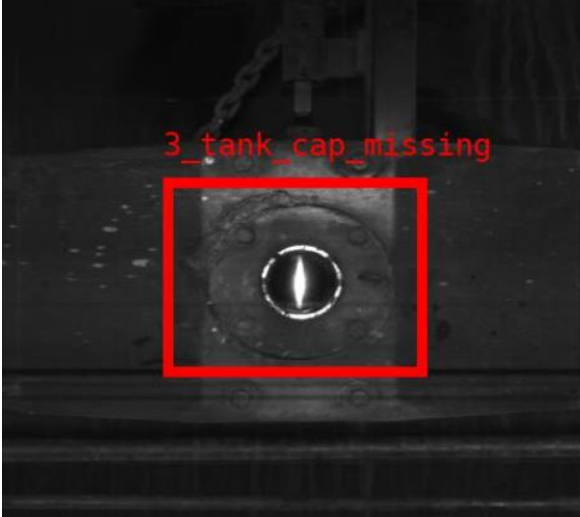
Algorithm Tank Car Missing
Cap (D0001)

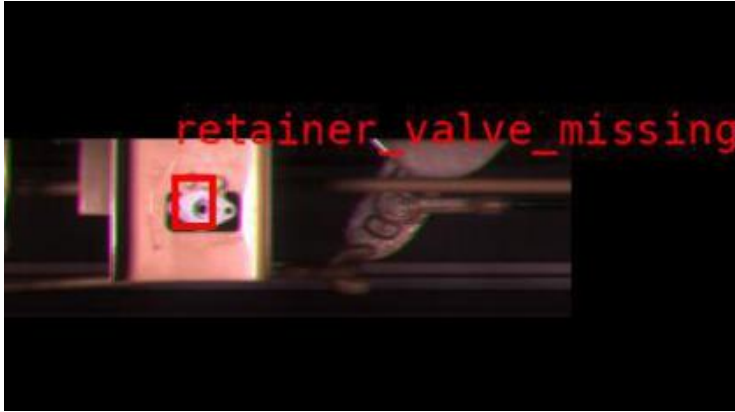
Algorithm Retainer Valve Missing
(D0045)

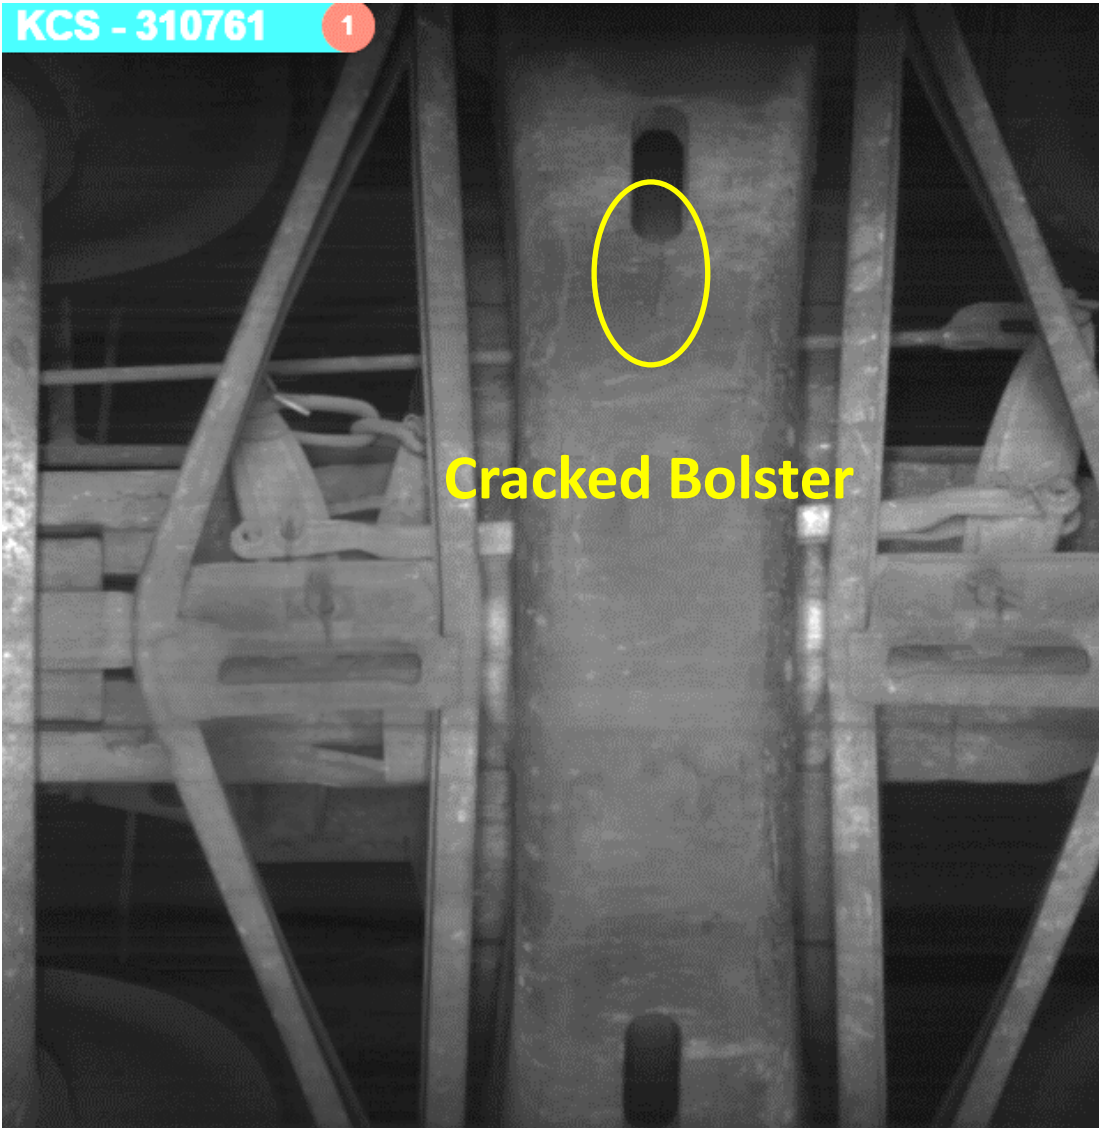
KCS - 310761

Cracked Bolster

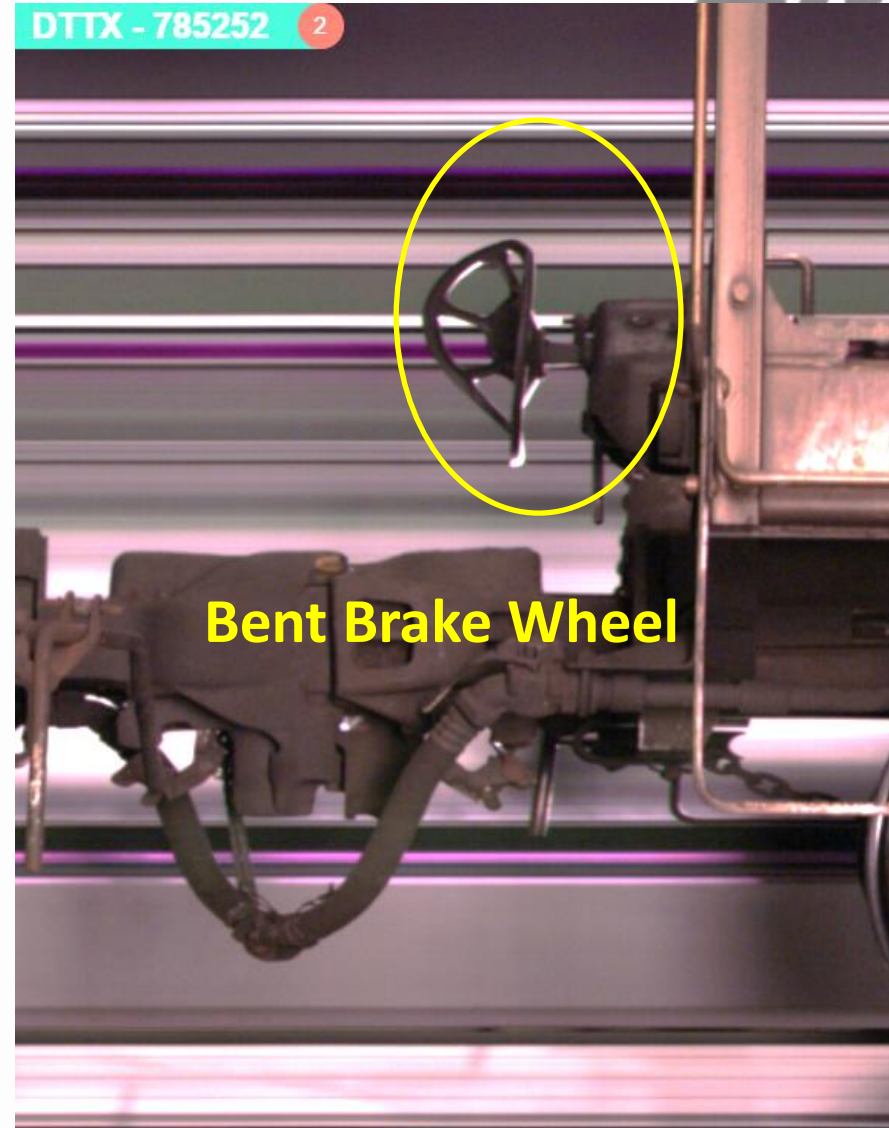
DTTX - 785252

Bent Brake Wheel

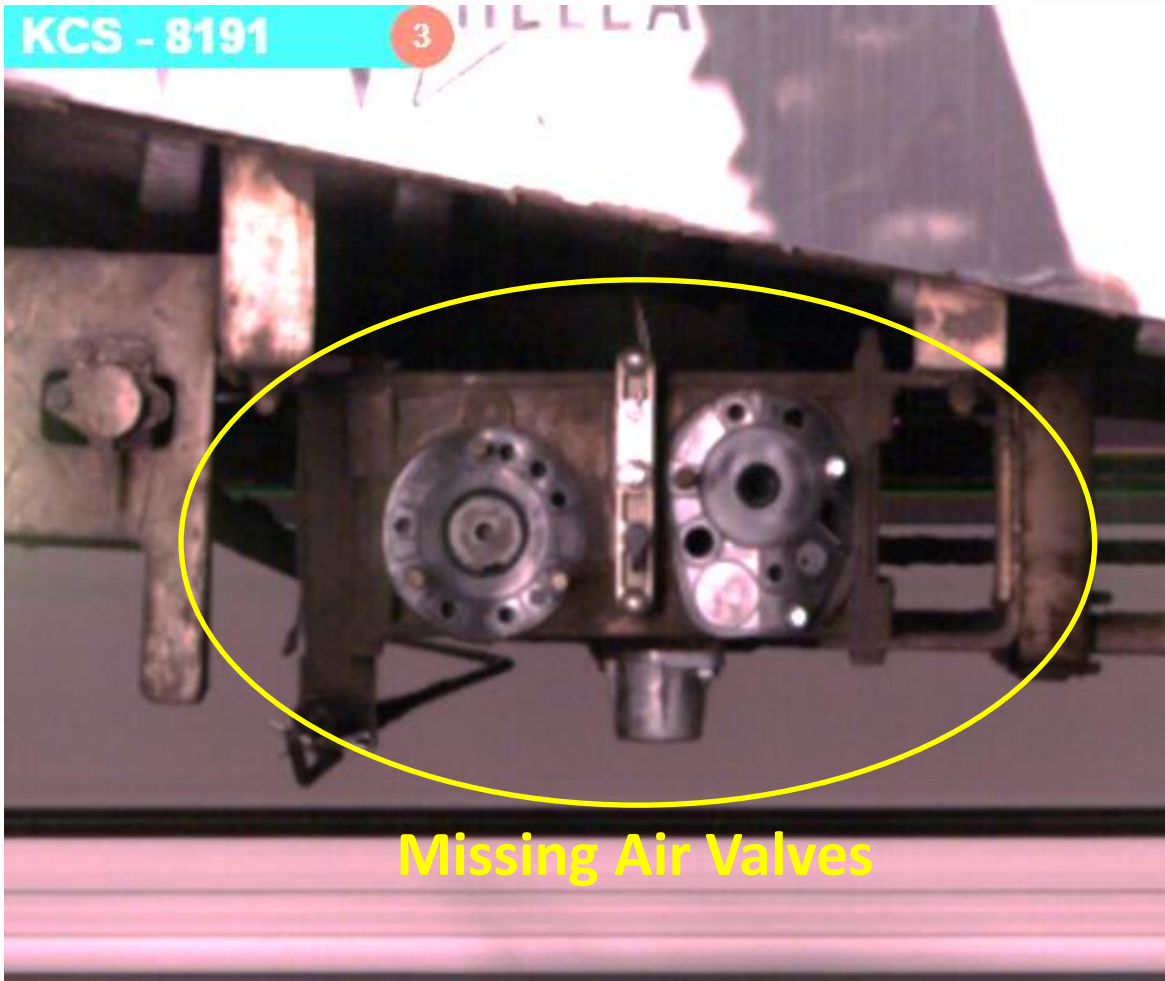
Missing Air Valves

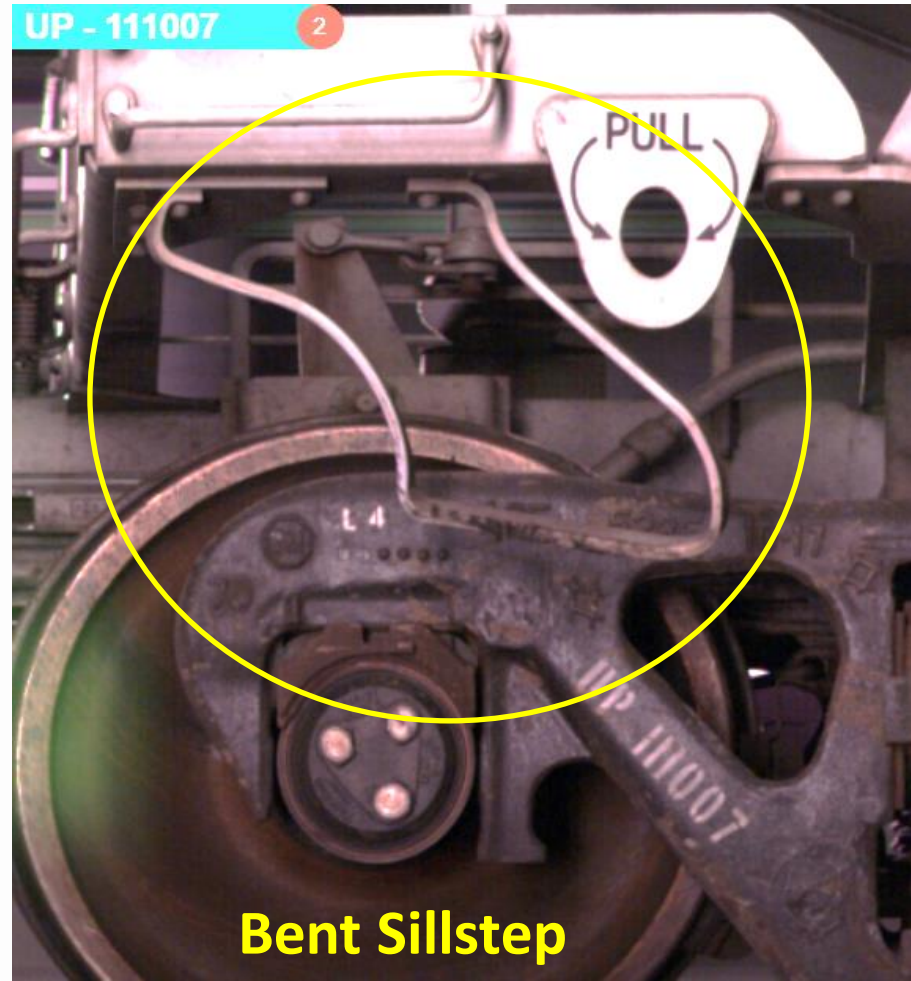
Bent Sillstep

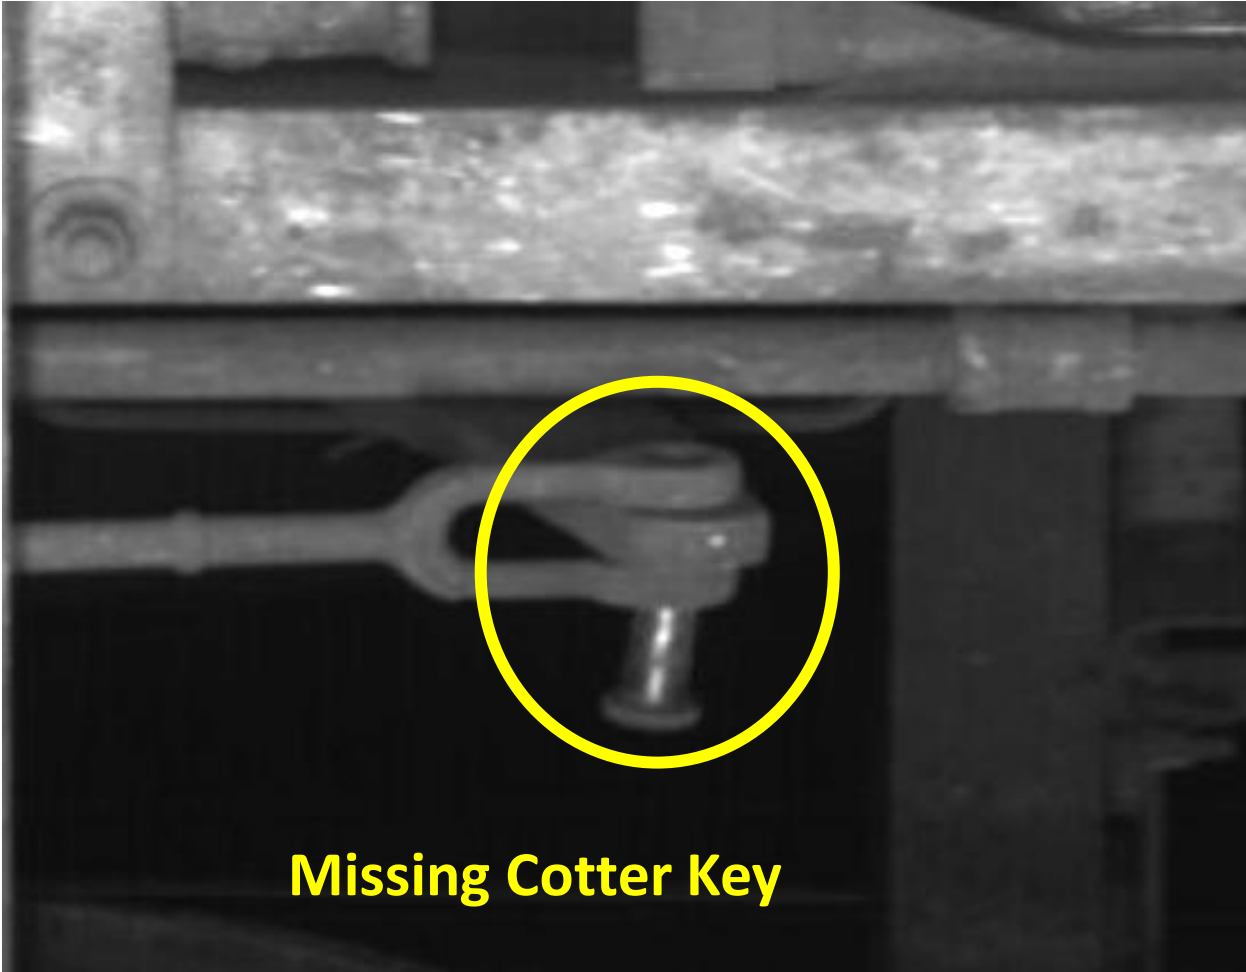
Missing Cotter Key

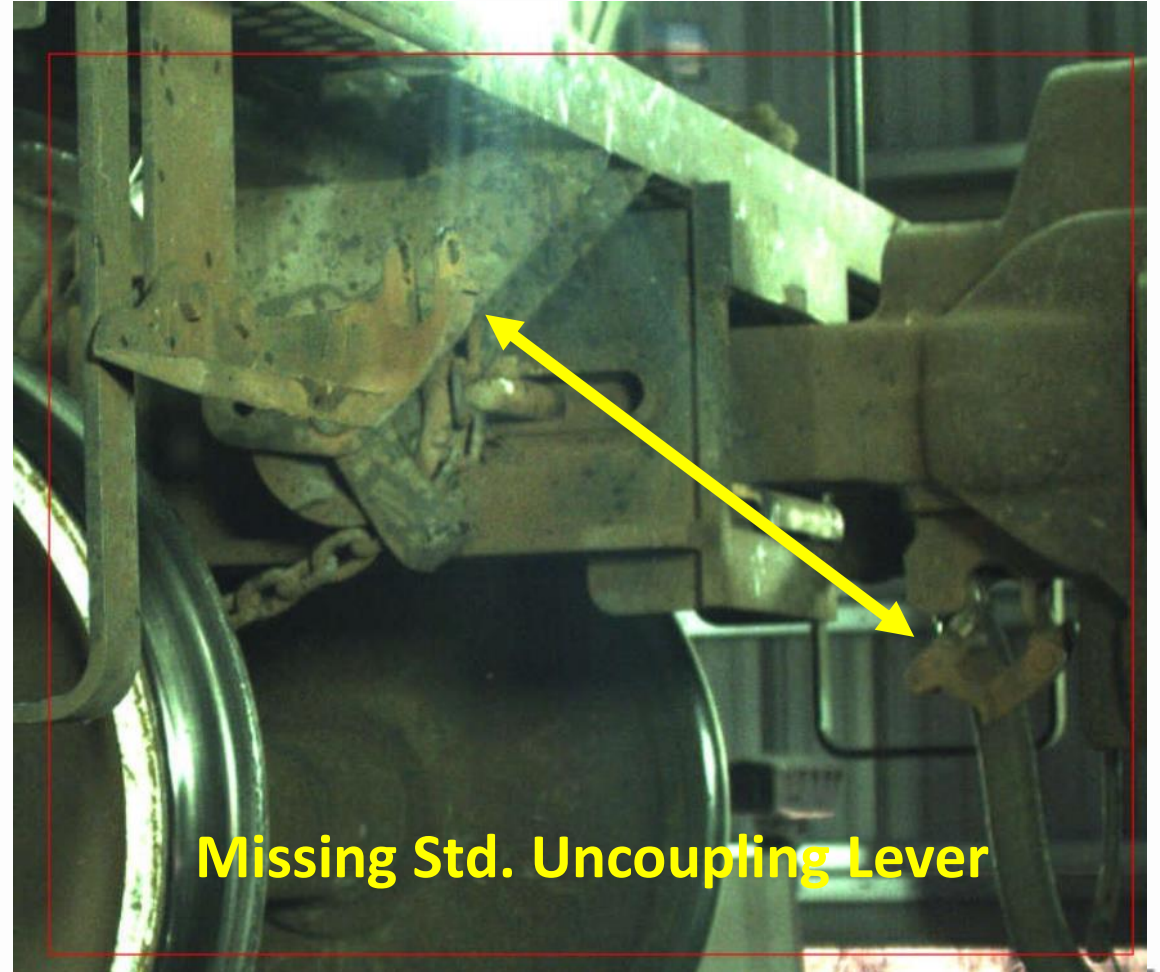
Missing Std. Uncoupling Lever

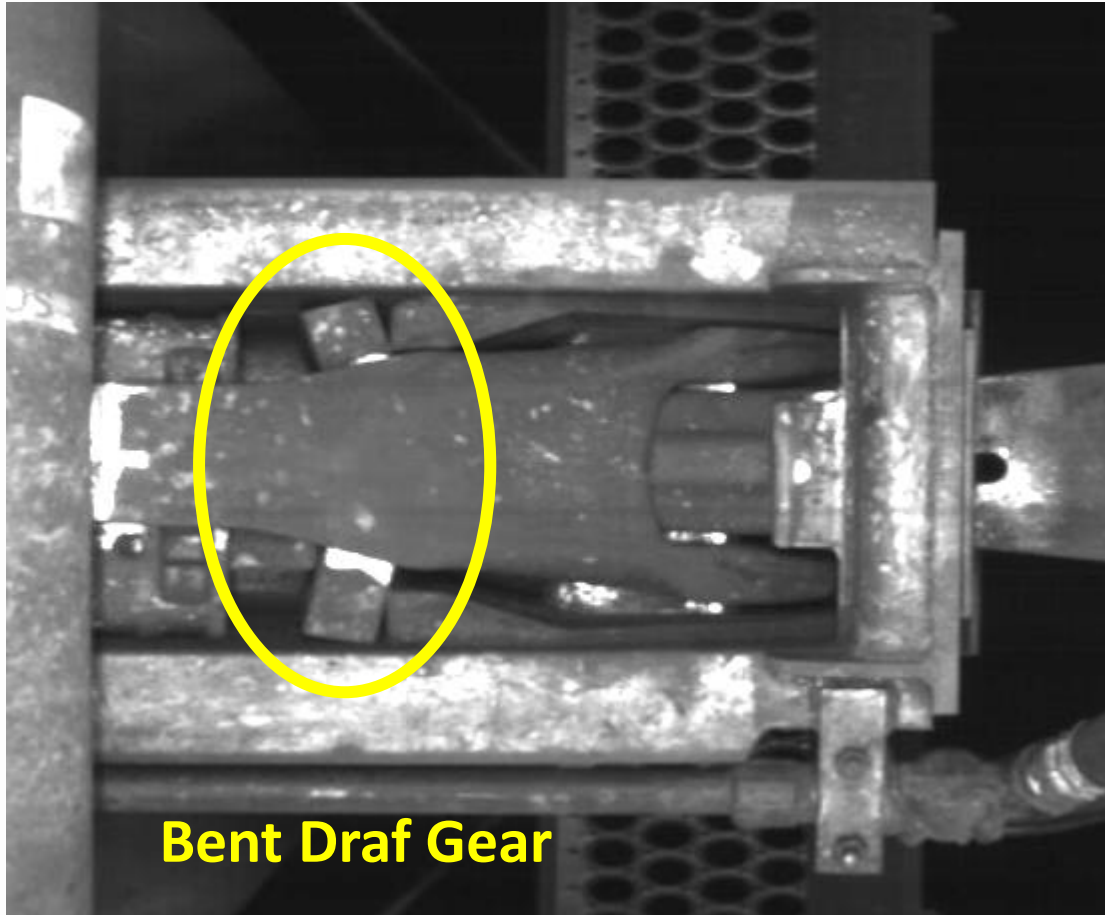
Bent Draft Gear

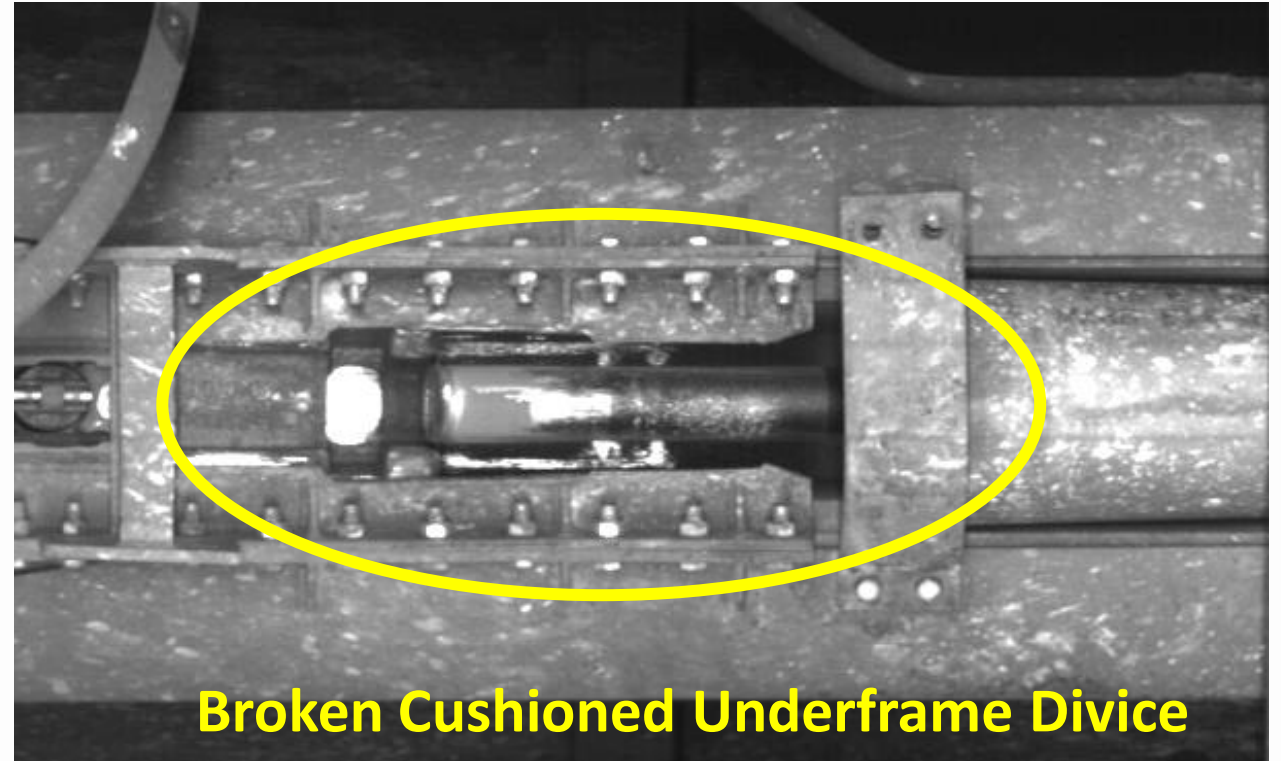
Broken Cushioned Underframe Device

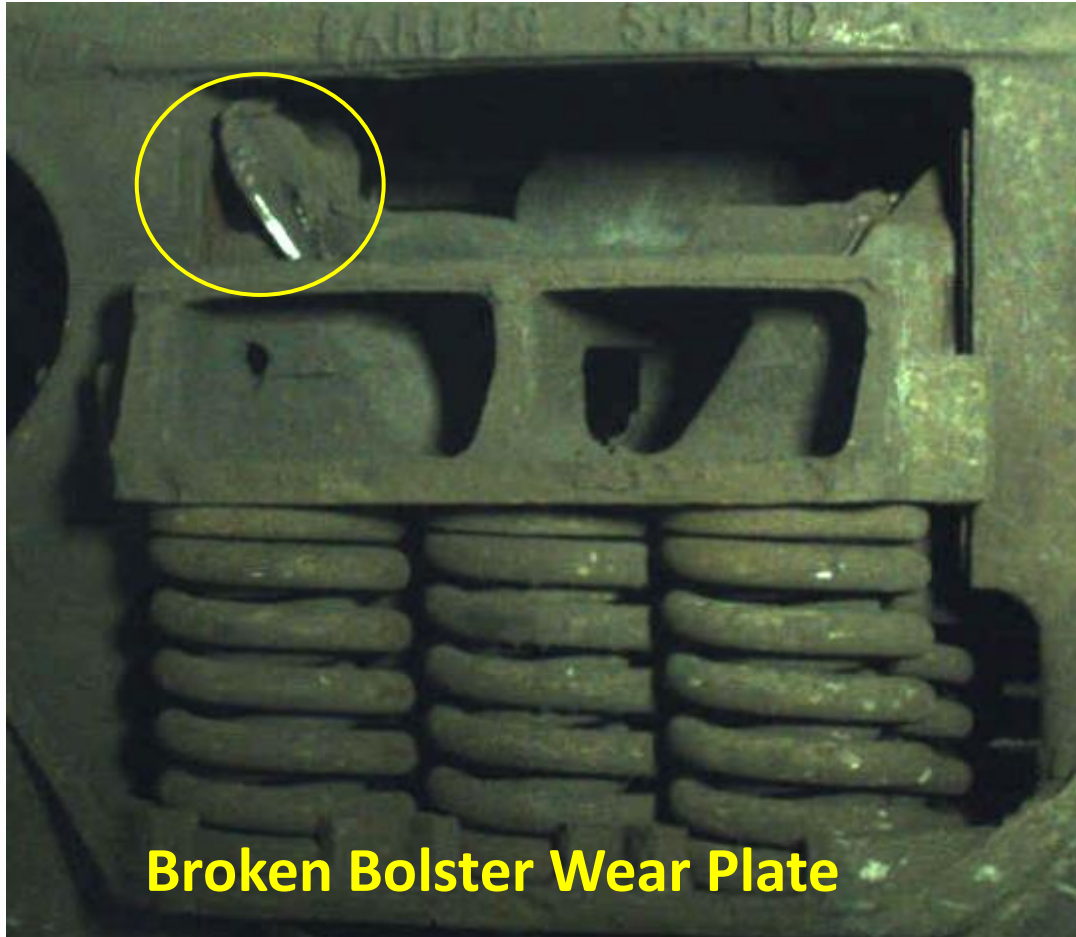
Broken Bolster Wear Plate

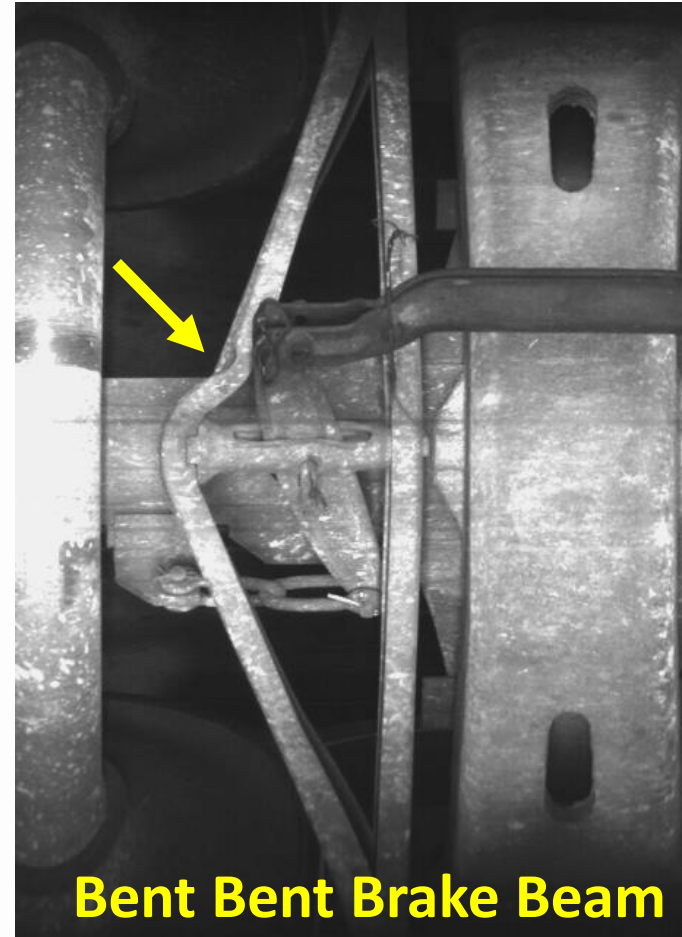
Bent Bent Brake Beam
