Advancement of Rail Wheelset Components and Performance

MxV Wheel Research and Testing

Project Objectives

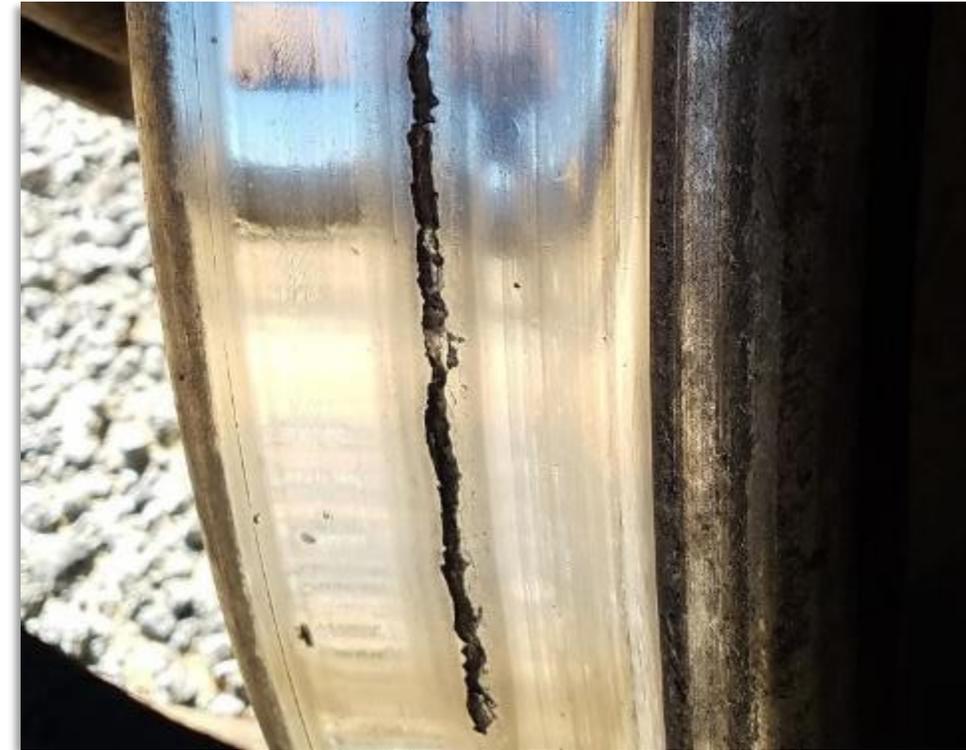
Surface-initiated cracks:

- Steering tractions and thermal effects
- Can be detected visually
- Material loss can lead to high impacts

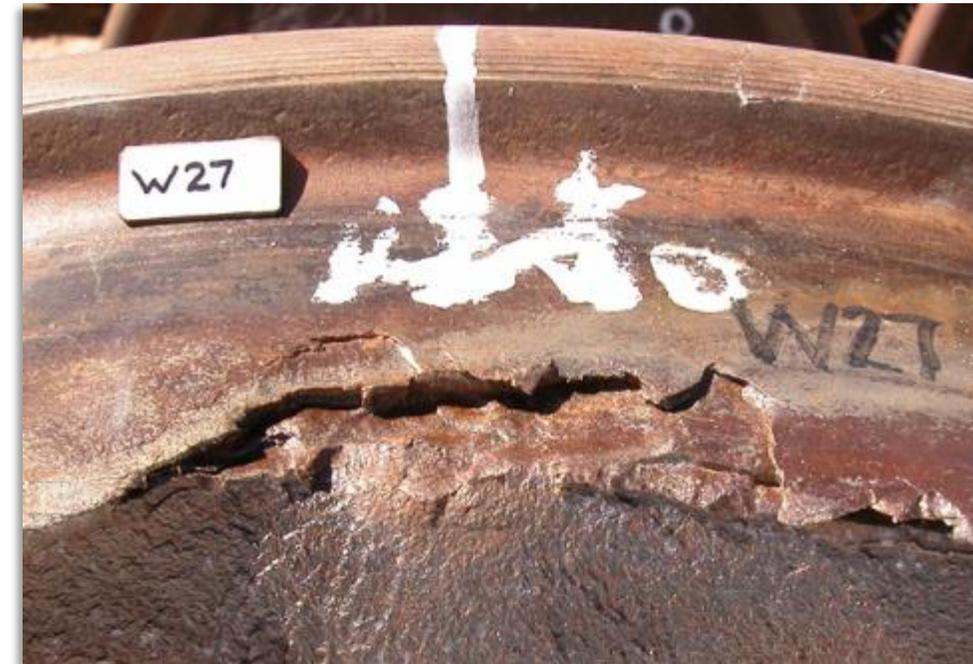
Subsurface cracks:

- Detectable only by ultrasonic methods
- Surface damage, such as shelling, is not always present
- Could develop into potential wheel failure modes such as a Vertical Slit Rim, though these are rare

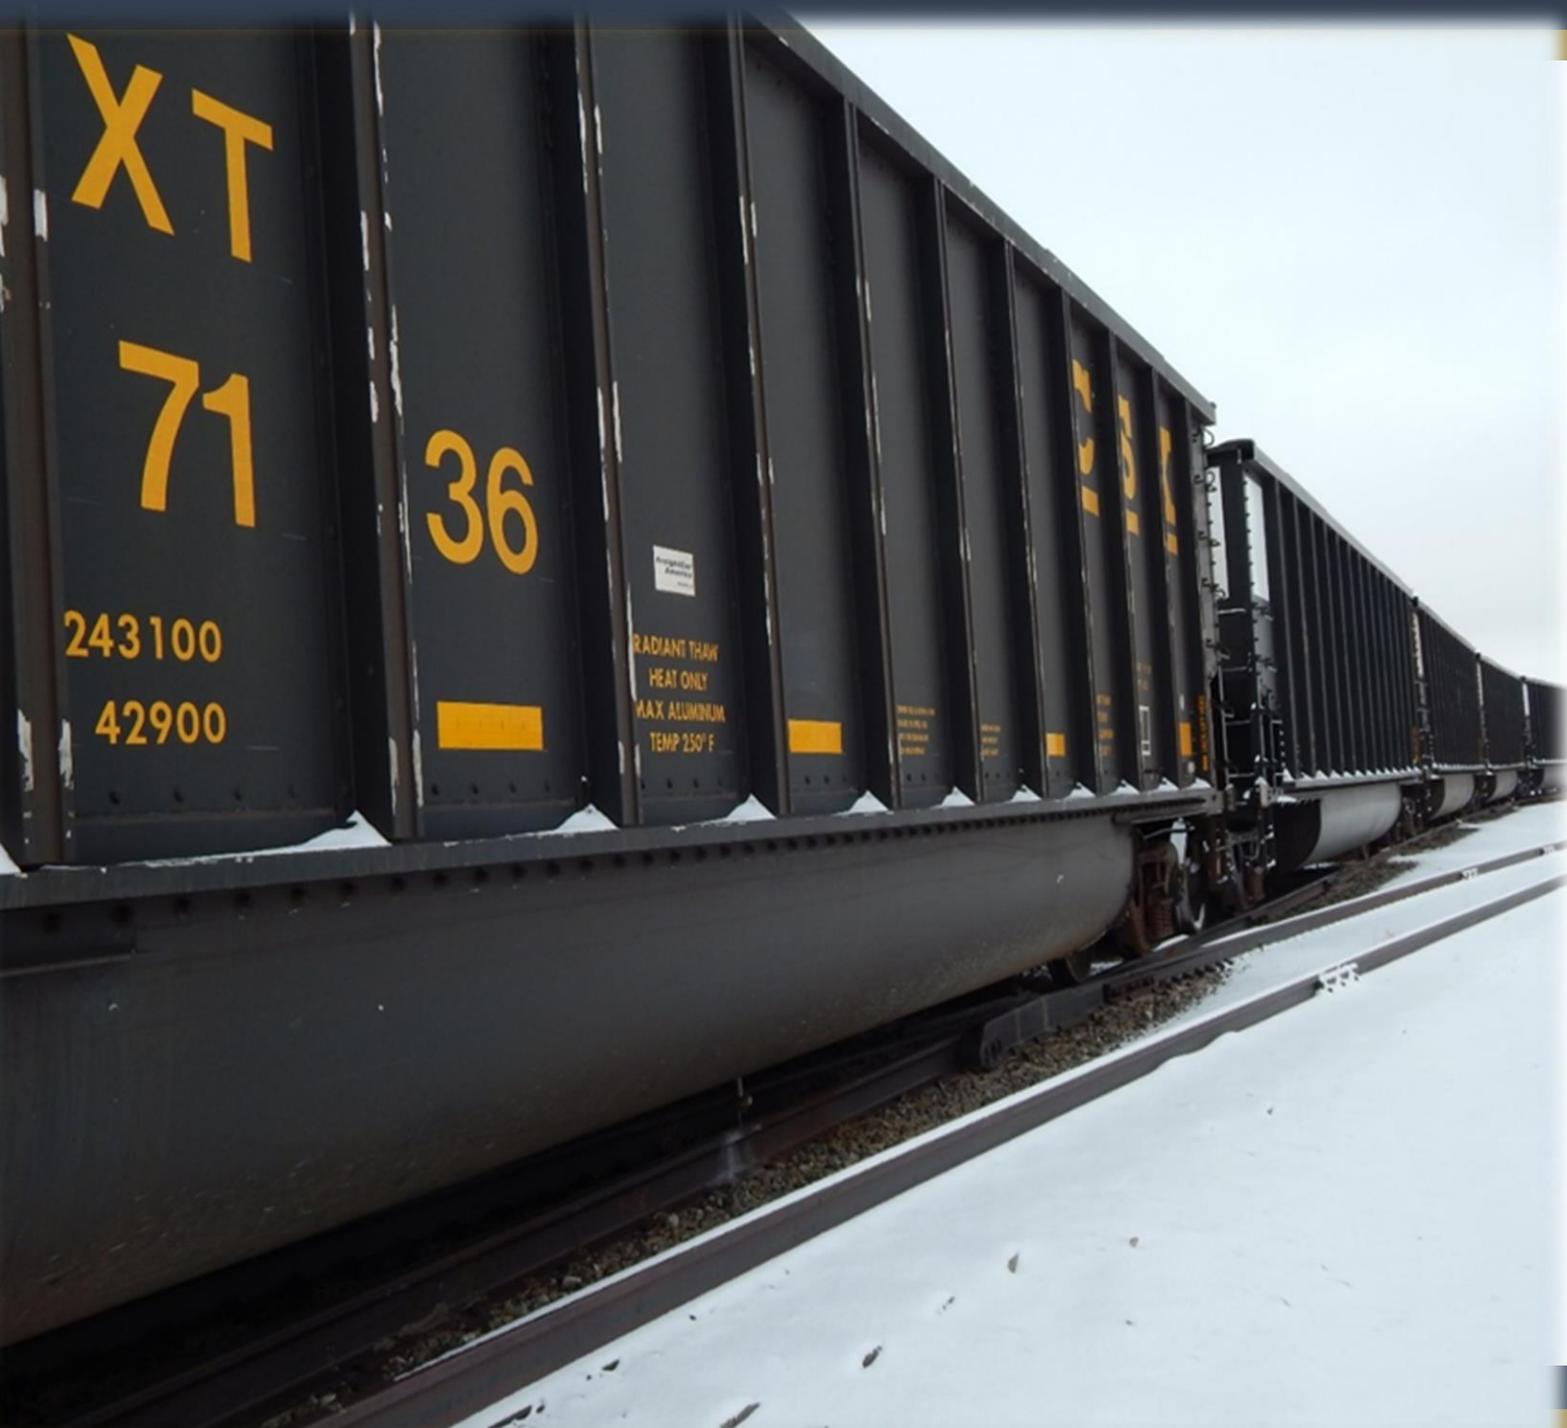
- HPW2 test phases:
- Laboratory testing complete
- On-track testing at F.A.S.T.
 - Began 2017
 - Ten similar cars, 40 test wheelsets
 - Loaded to 286,000 pounds
 - Three wheelsets per supplier
- Also testing in revenue service

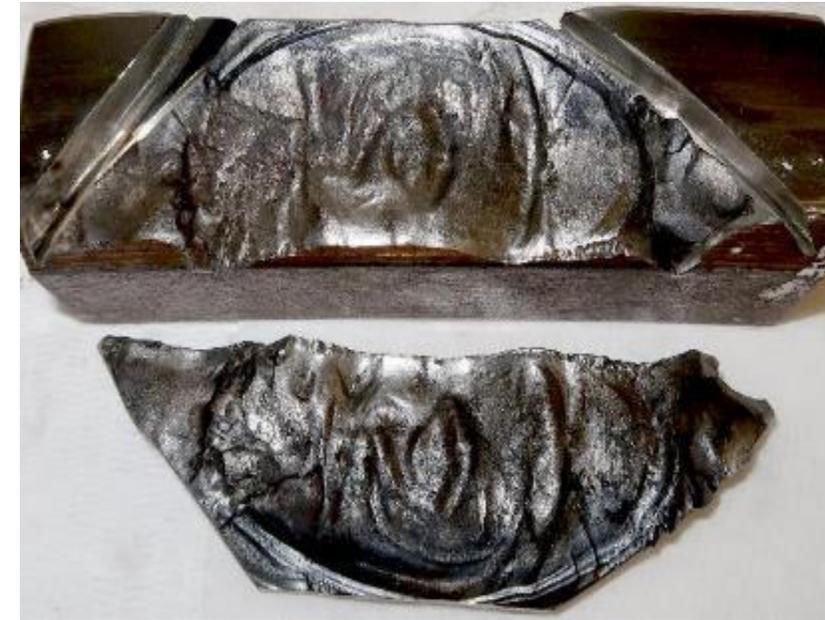
HPW2 F.A.S.T. Removals

- Eight wheels removed for cause
- Average of 84,000 miles at FAST
- One removed for wear

- **HPW2 wheels continue to run at FAST**
 - Eight wheels removed for cracks in rim
 - Wear rate generally correlates with hardness
- **HPW2 wheels running in revenue service**
 - No removals
- **Wheel performance determined by multiple properties**
 - Bainitic wheels have not performed well in these tests
 - Tensile to yield strength ratio is not a definite predictor of performance, but low values did not perform well in these tests

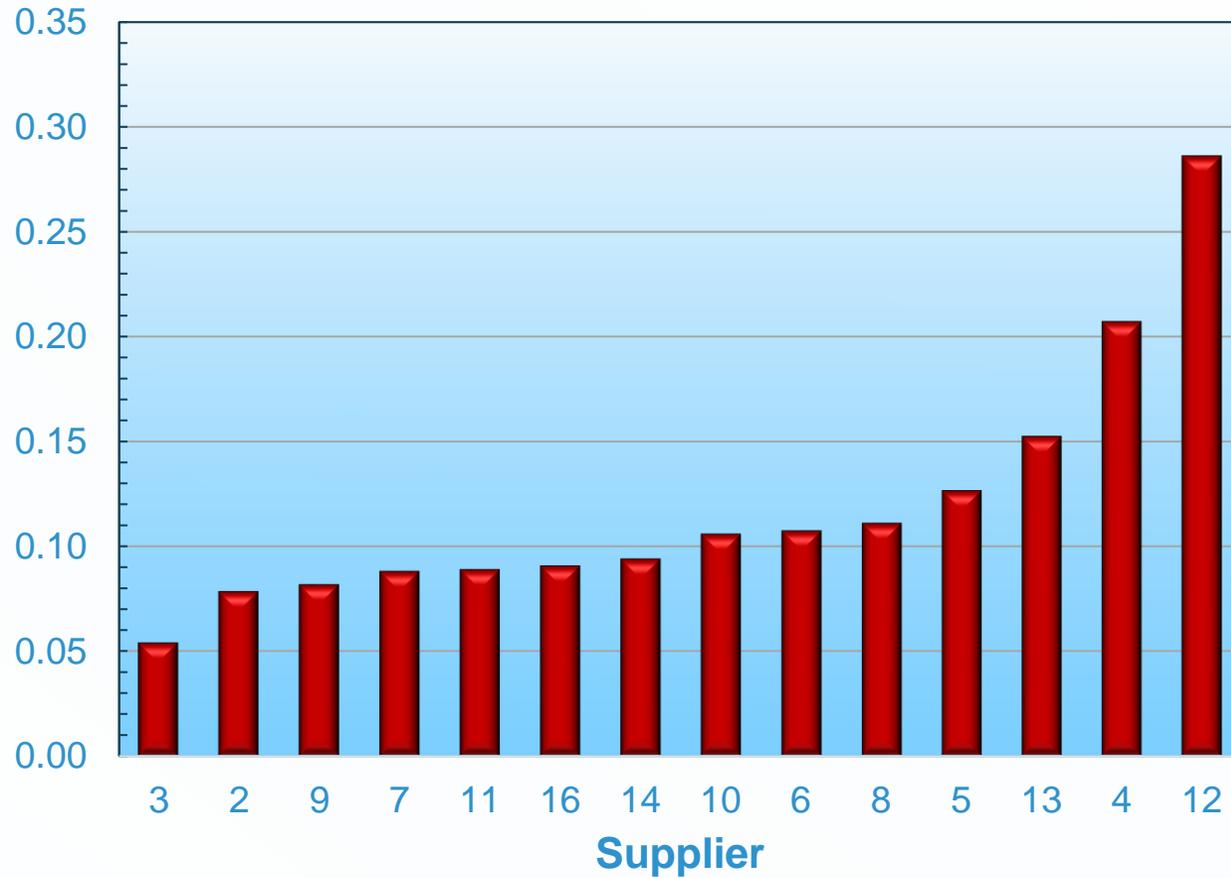
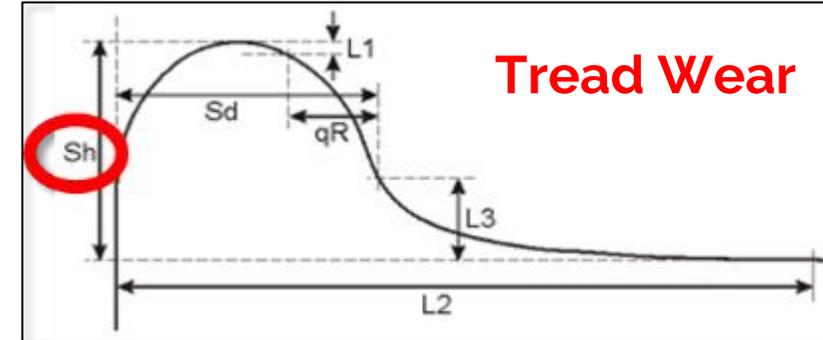
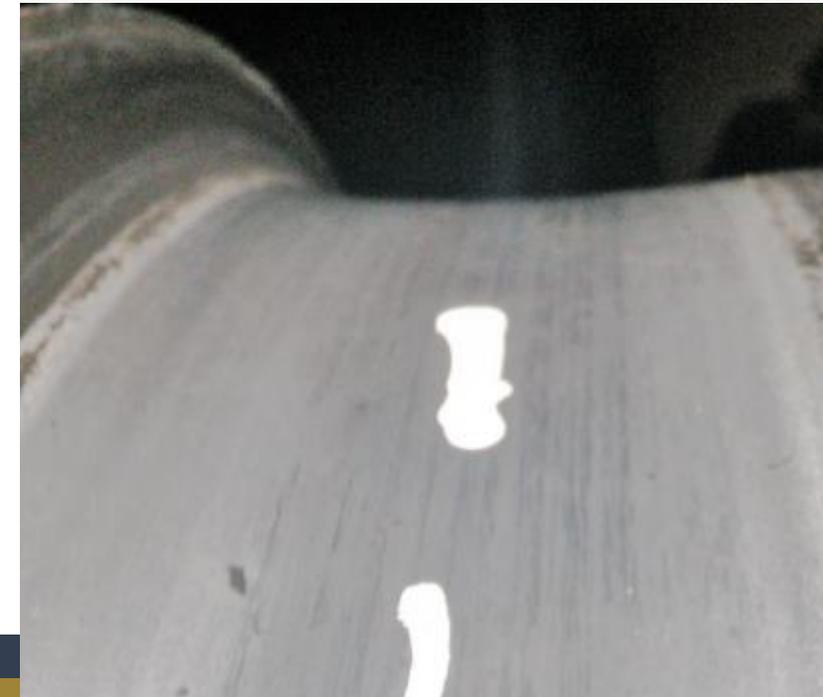
Tread Wear at F.A.S.T.

Tread Wear, Inches per 100,000 Miles

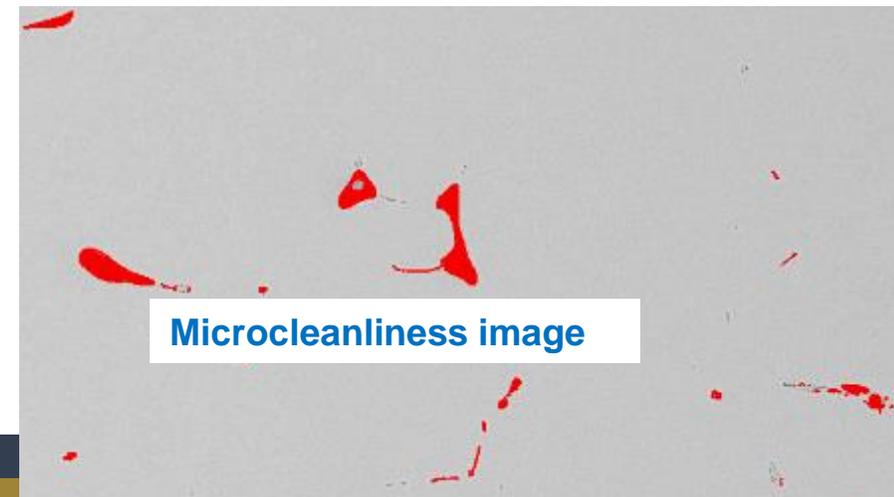
- **Many properties and parameters influence wheel life and performance**
 - Microstructure
 - Tensile to yield strength ratio
 - Microcleanliness

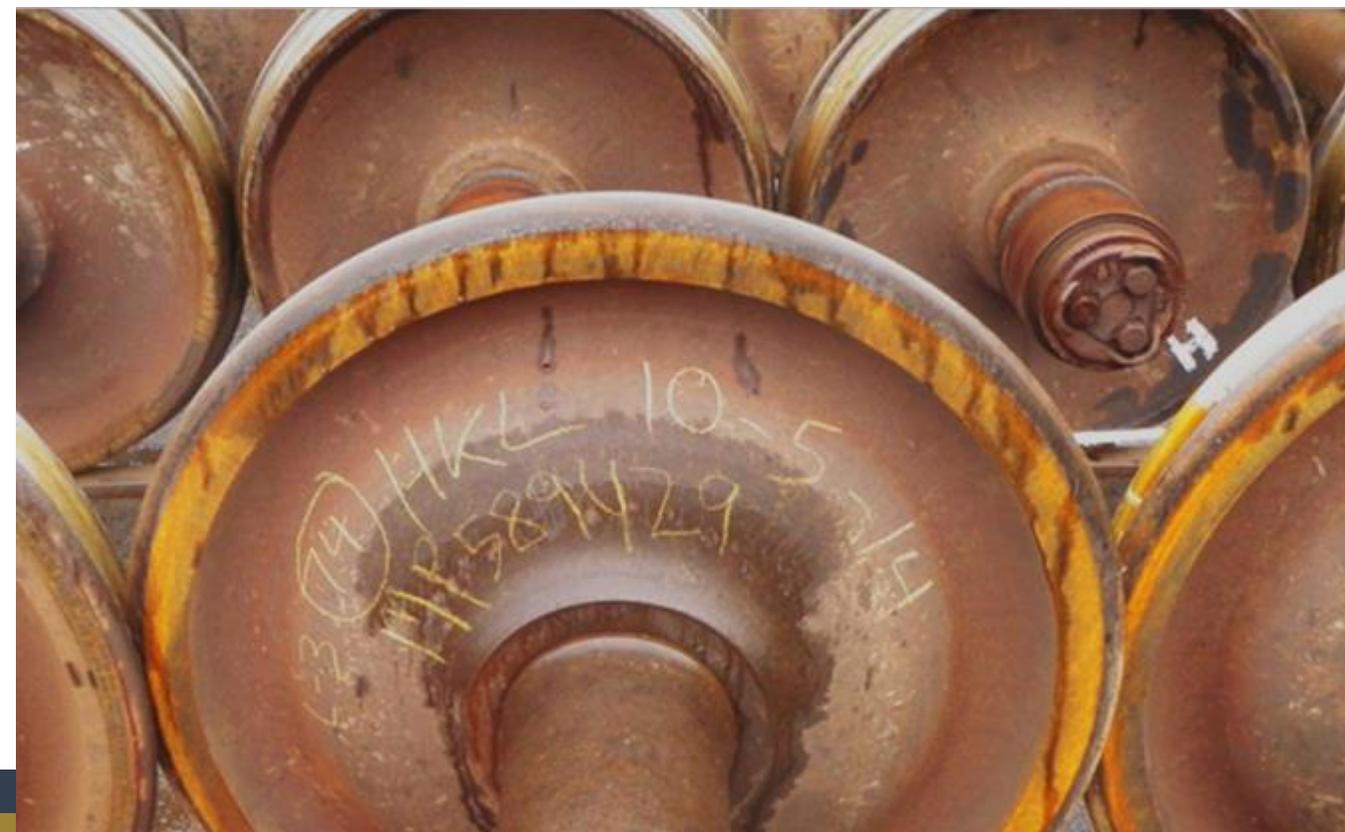
Observación: Microstructure

Both pearlitic/bainitic wheels exhibited excellent mechanical properties

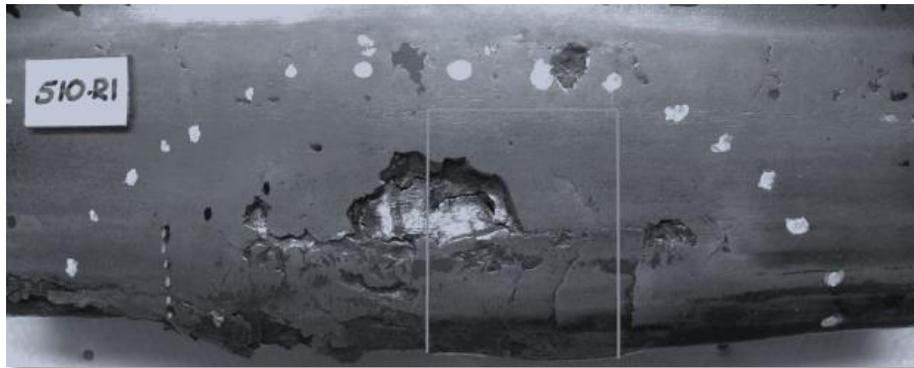
In these tests, two steels with bainitic microstructure were submitted. Both bainitic steels had multiple early removals at FAST

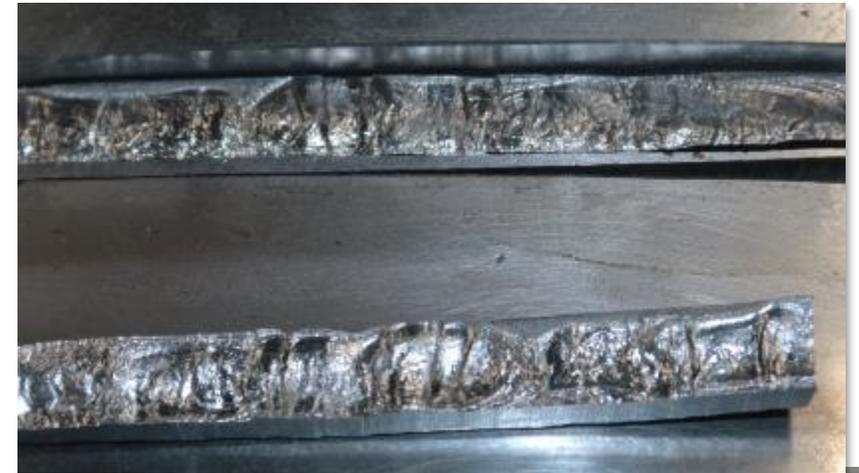
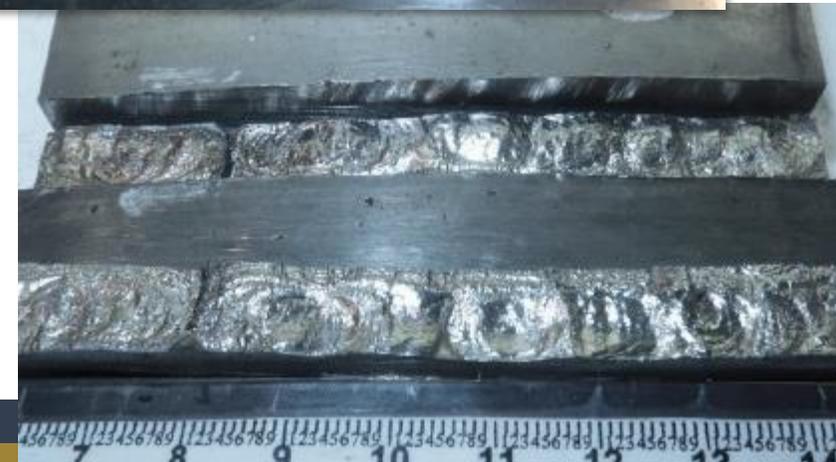
Shattered rim under surface

Subsurface crack bands

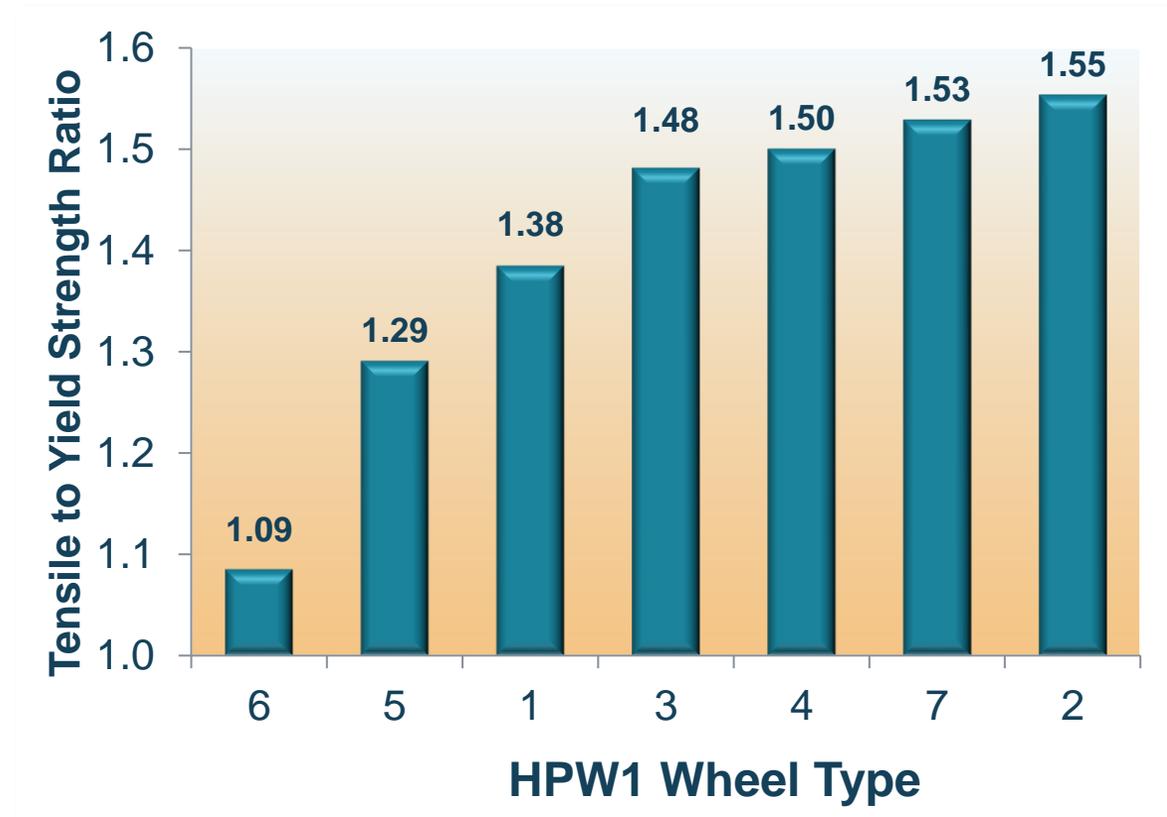
Observación: Tensile-to-Yield Strenght Ratio

- Tensile-to-yield strength ratio is a measure of the amount of plastic deformation a material can undergo before fracture
- Generally, a higher value indicates higher resiliency
- Low ratio means yield strength and tensile strength are closer together

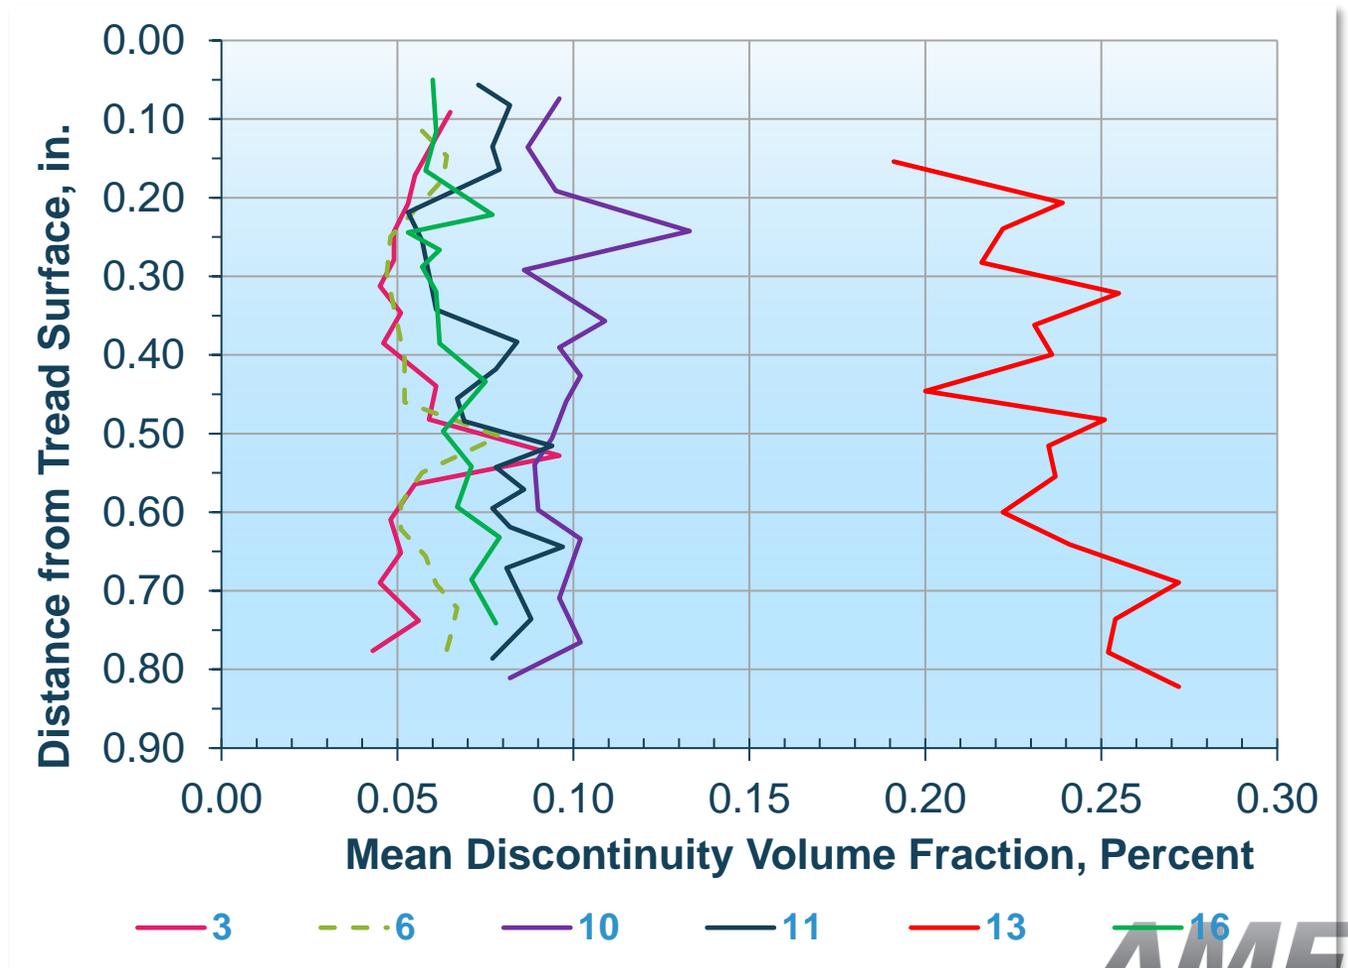
Observación: Microcleanliness

- Microcleanliness varies across manufacturers and processes
- HPW tests indicate that wheels are tolerant of voids and inclusions over a wide range of values
